BREAKWATER BEACH

Breakwater Beach Landing 2012 existing amenities and signage

Updated 1-25-12

Breakwater Beach recommendations

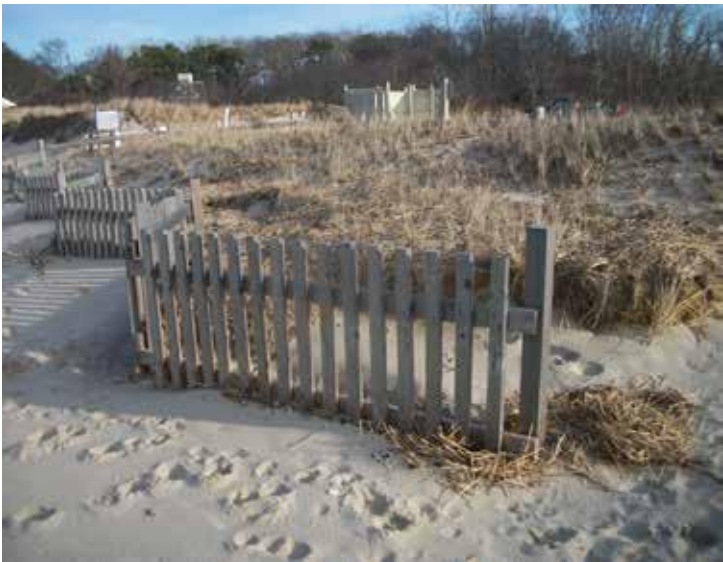
West side of parking area showcasing the success of dune restoration project.

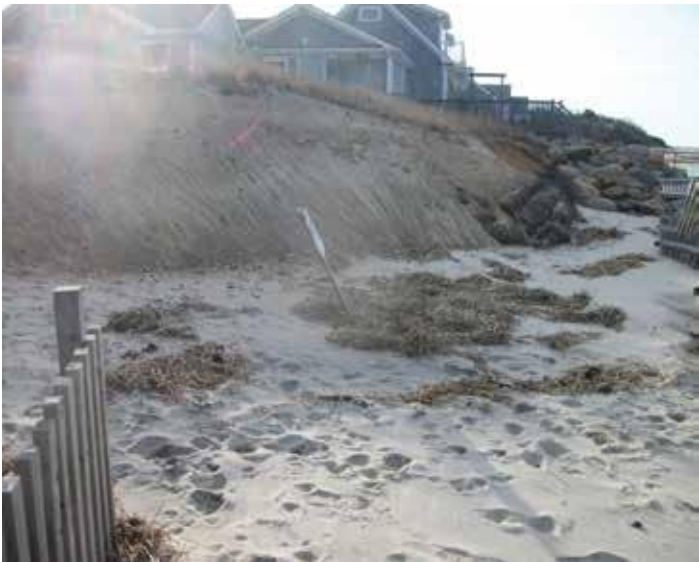
Recommended site for sand drift fencing extension with plantings.

There are two sites marked above that have obvious increased erosion occurring. With the success of the 2011 dune restoration project, we recommend extending the dune (with plantings) and sand drift fencing on the west side of the parking lot and joining it with the adjacent existing fencing. We also recommend erecting a new sand drift fence section on the east side of the parking area with plantings to combat erosion.

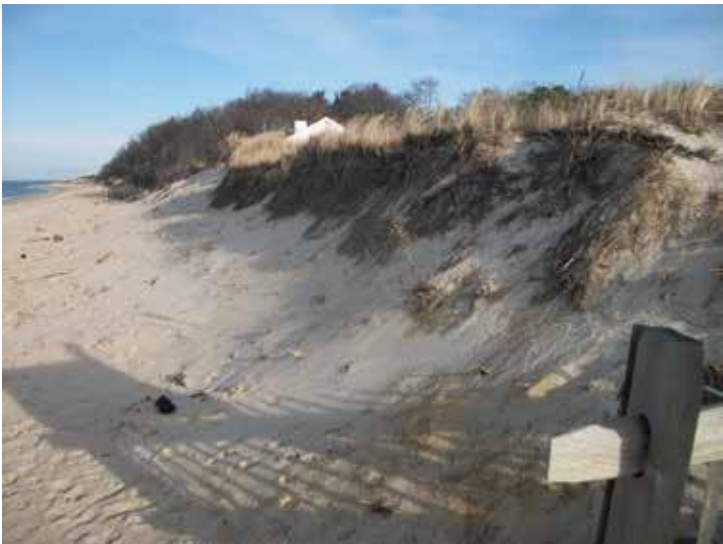
East side of parking area recommended for additional sand drift fencing installation and planting.

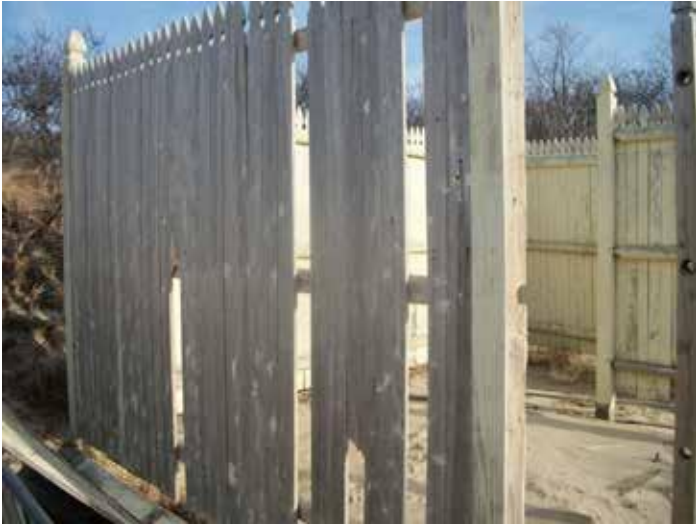
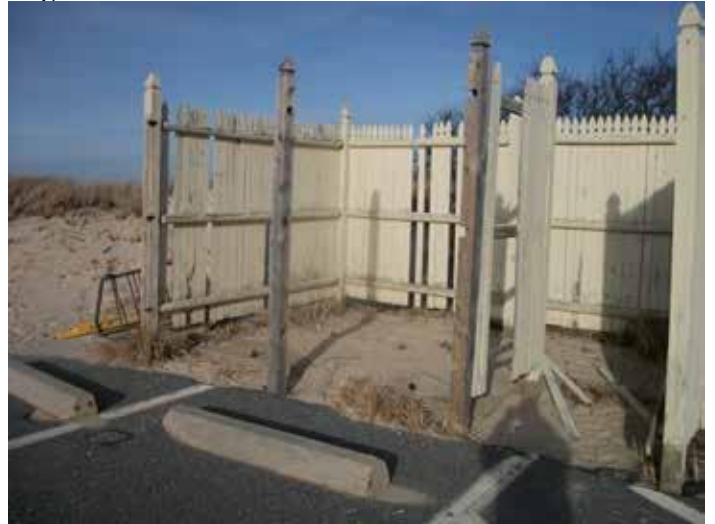
Recommended repairs to port-o-let enclosure. Boards need to be replaced and paint needs to be applied.

Repair or replace the existing port-o-let enclosure.

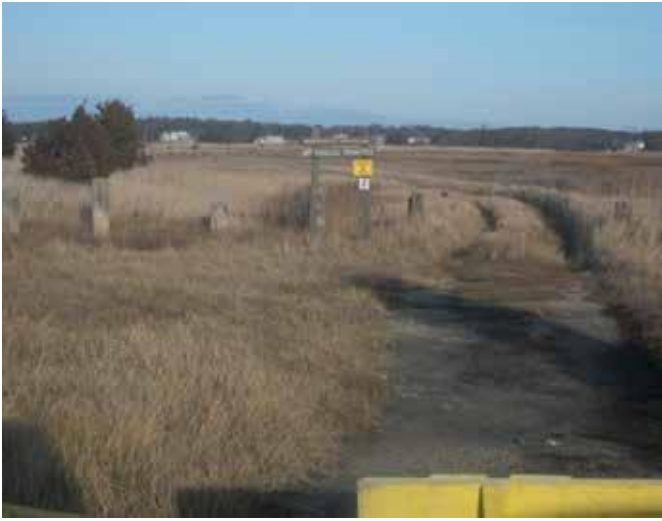
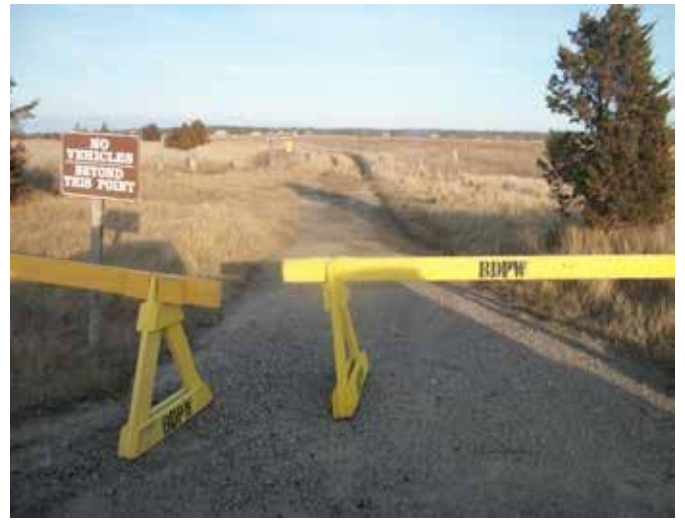
Currently there are temporary barricades restricting access to this area. Additional signage and split rail fence would help prevent illegal parking and damage to the marsh habitat.

Install no parking signs and split rail fencing at the entrance of the fire road. Last year there was illegal parking in this area that negatively impacted the marsh.

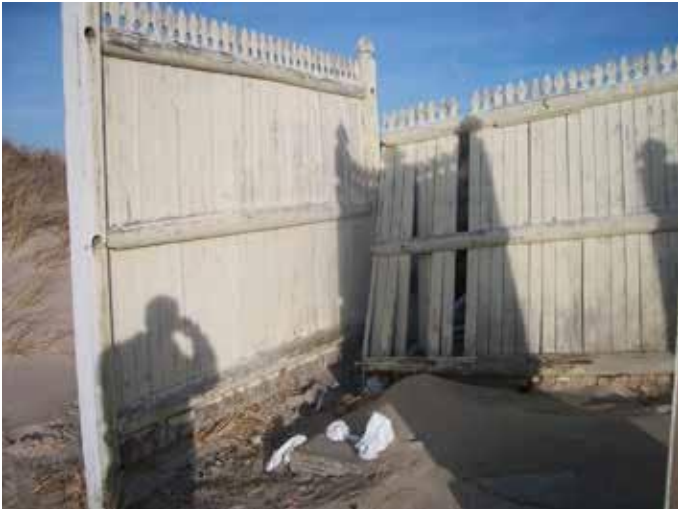
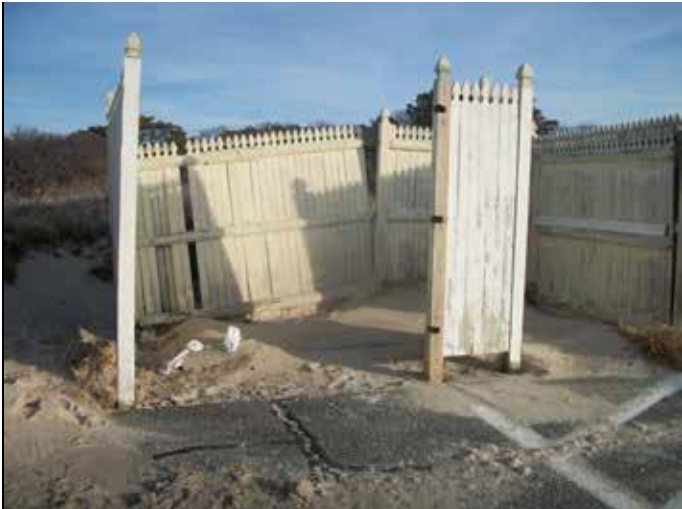
Recommended repairs to port-o-let enclosure. Boards need to be replaced and paint needs to be applied.

Repair or replace the existing port-o-let enclosure.

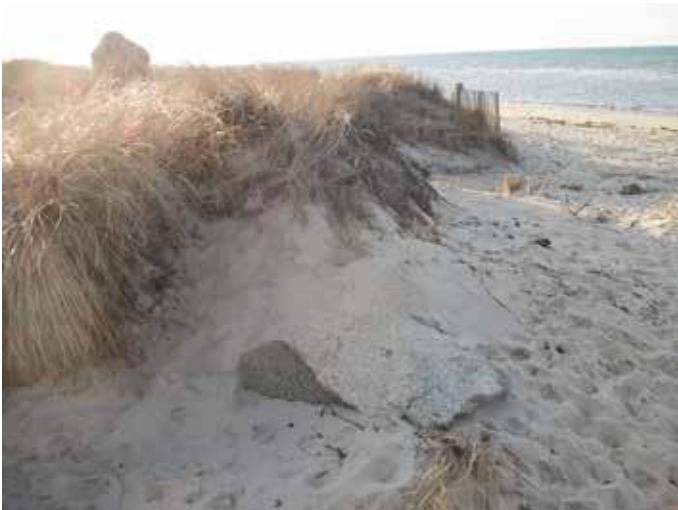
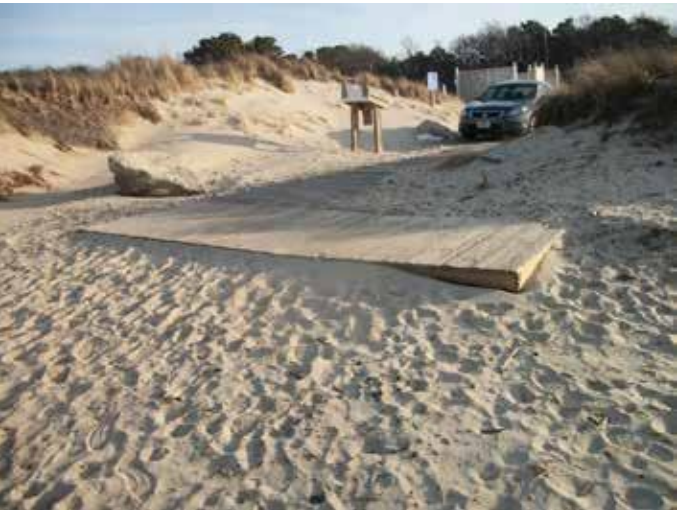
Recommended site for installing sturdy section of sand drift fencing and beach grass.

Support the small dune located between the entrances with a short section of sturdy sand drift fencing and nourish with sand and beach grass.

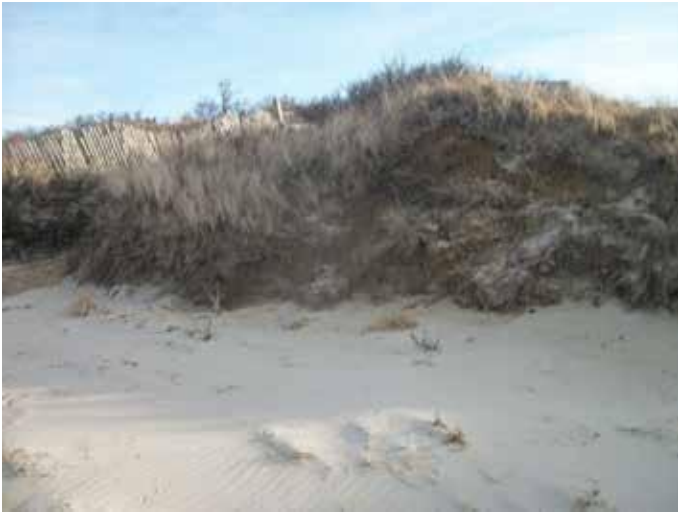
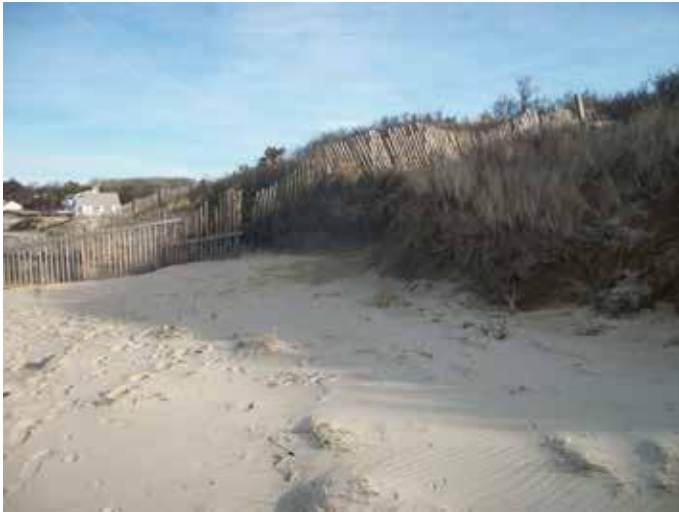
Location of the sturdy sand fence installation and beach grass planting. Stabilizing this area would help protect the dune in front of the parking area. At current erosion rates, in approximately 10 years the edge of the parking lot will be threatened.

Install sturdy sand fencing at the base of the landing to reduce coastal erosion.

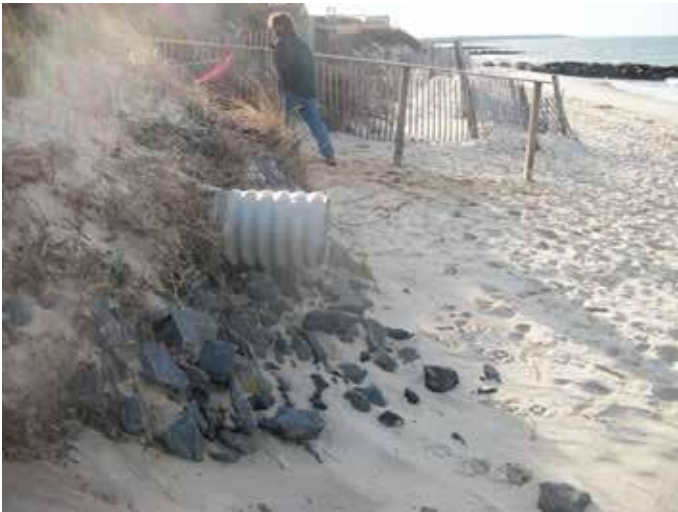
Area east of beach path recommended for sturdy sand drift fencing installation and beach grass plantings

Install sturdy sand fencing and beach grass plantings at the base of the landing to reduce coastal erosion.

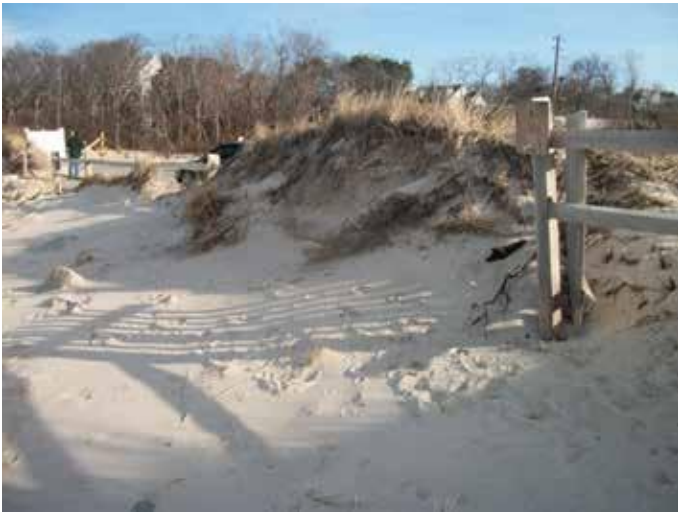
Recommended site for sturdy sand drift fencing
(West side of beach entrance)

Install sturdy sand fencing and beach grass plantings on both sides of the public beach access. Recent winter storms have washed away the protective dune along the north end of the parking area. During severe storms water frequently washes over the dunes into the parking lot.

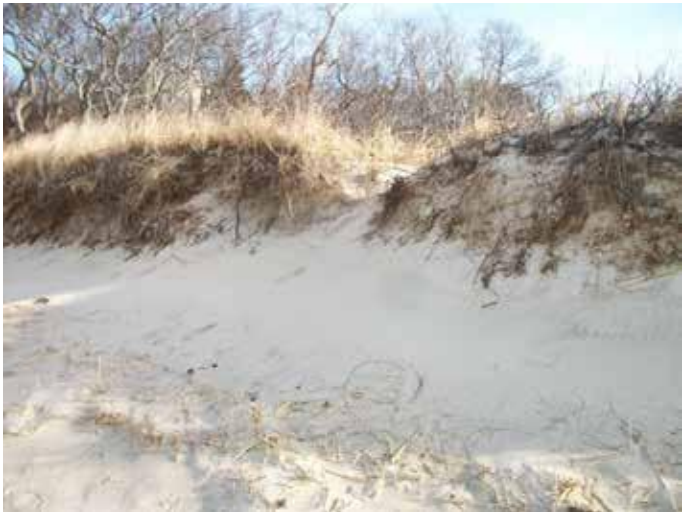
Recommended site for sturdy sand drift fencing
(East side of beach entrance)

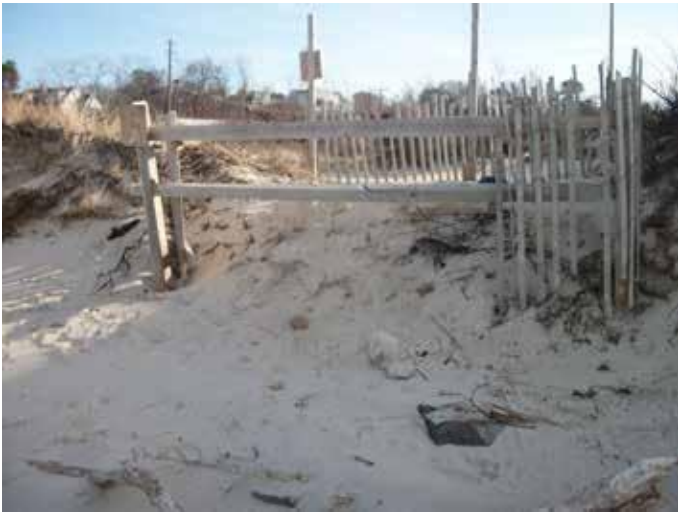
Replace existing snow fencing with sturdy sand drift fencing

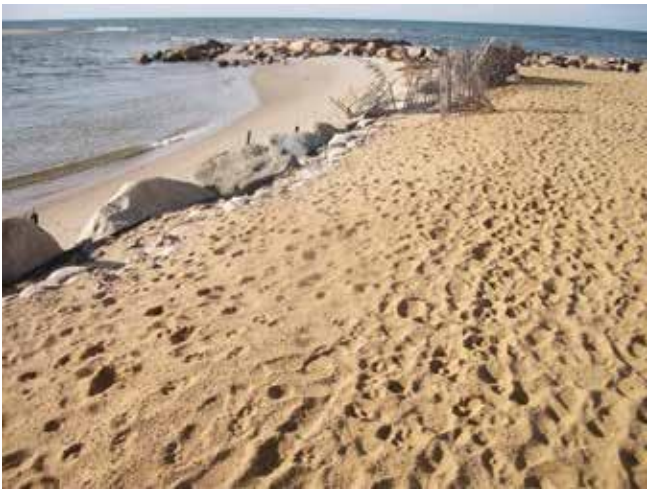
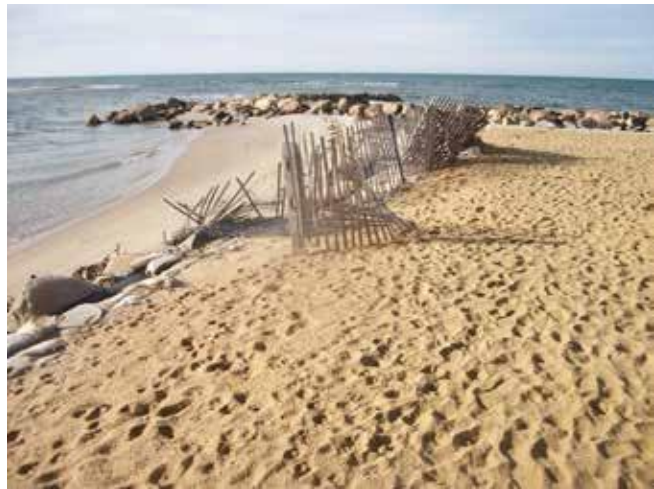
Replace existing split rail fencing and snow fencing where existing fencing was

Replace split rail and snow fencing on west end of new beach area

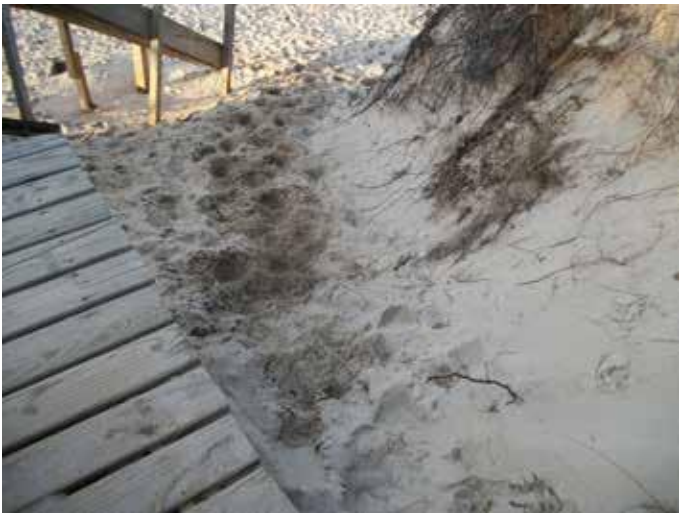
Evidence of increased erosion because of foot traffic

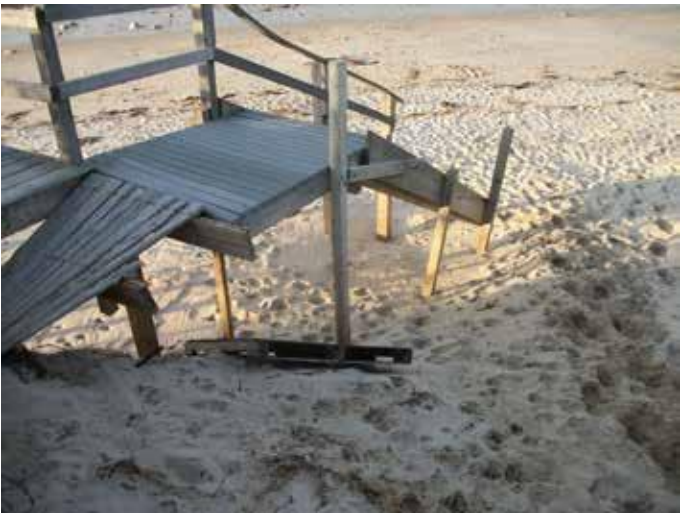
The coastal dune is eroding at approximately 0.39 feet per year. The existing overlook and stairway is in danger of collapse onto the beach, and needs to be removed and rebuilt. Last year we added about 10 feet in length to the stairway as it ended about 3 feet above the beach. This longer stair was buried into the beach. This year the drop to the beach is about 4' due to continued erosion.

Condition of stairs has become dangerous

Currently there is an approved plan to remove the existing stairs and replace them with something that will reduce impact on the dune and provide a safe access point to the beach. In addition to the stairs it is recommended that sturdy sand drift fencing be installed on both sides of the stairs and beach grass planted behind. This will help to stabilize the current dune and act as a buffer during winter storms.

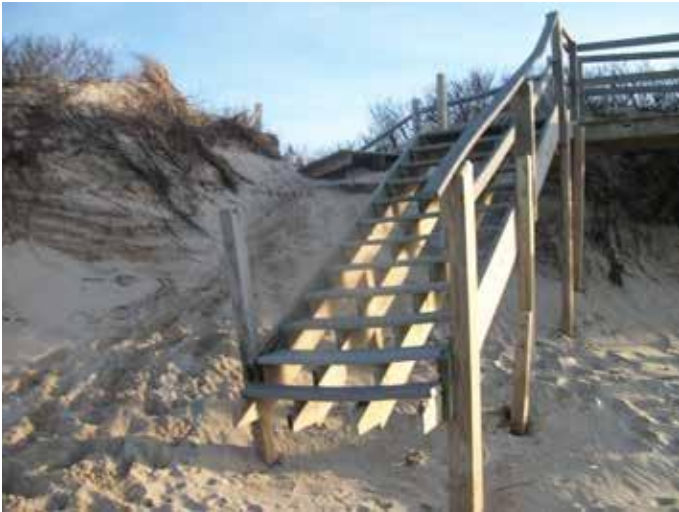
Replace existing stairs with a low impact design

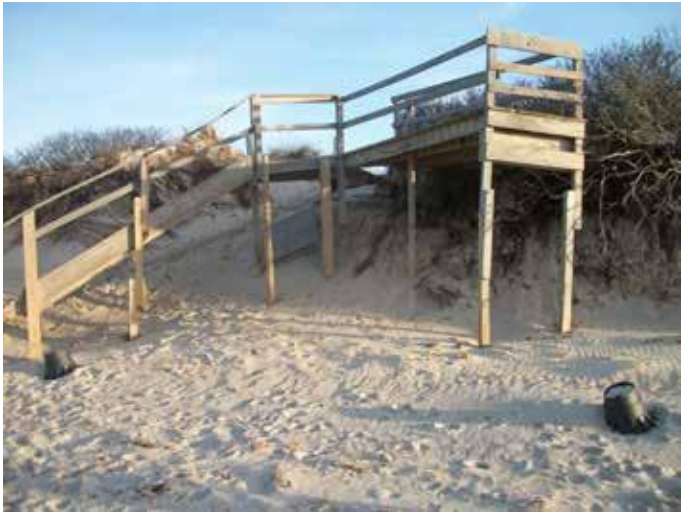
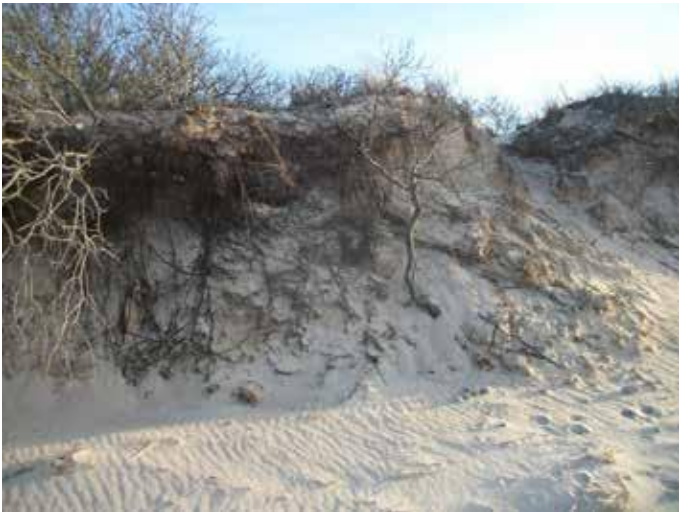
Install sturdy sand drift fencing on both the east and west side of the stairs

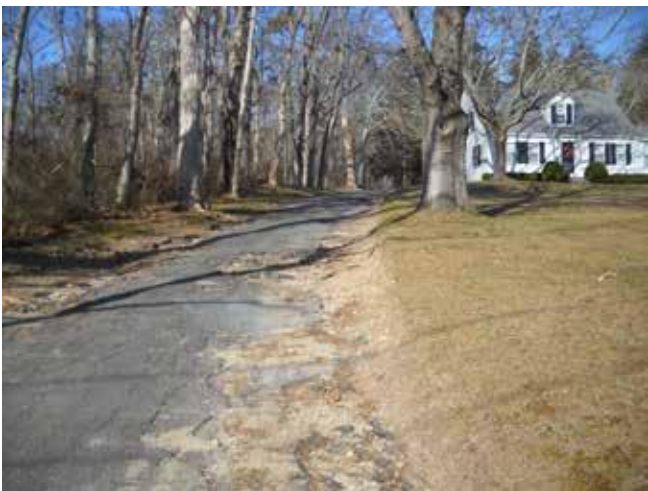
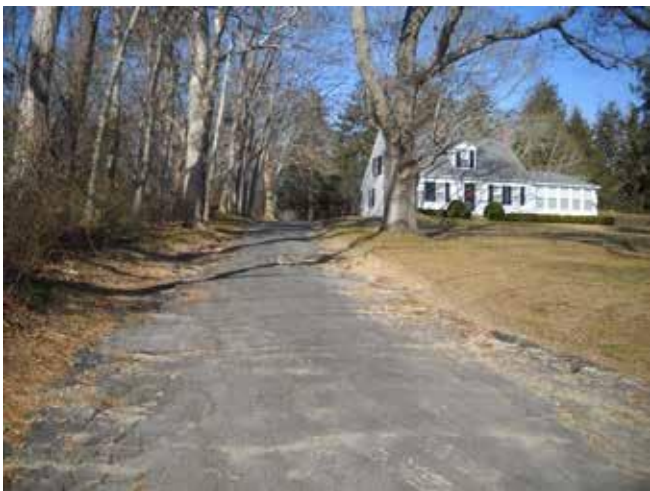
Entrance repairs to driveway. Current driveway is broken and signs of erosion are present.

Driveway improvements set for Spring 2012 (DPW)
